METALS HANDBOOK

VOL. 9
FRACTOGRAPHY AND ATLAS OF FRACTOGRAPHY

8th EDITION

Fractography and Atlas of Fractographs

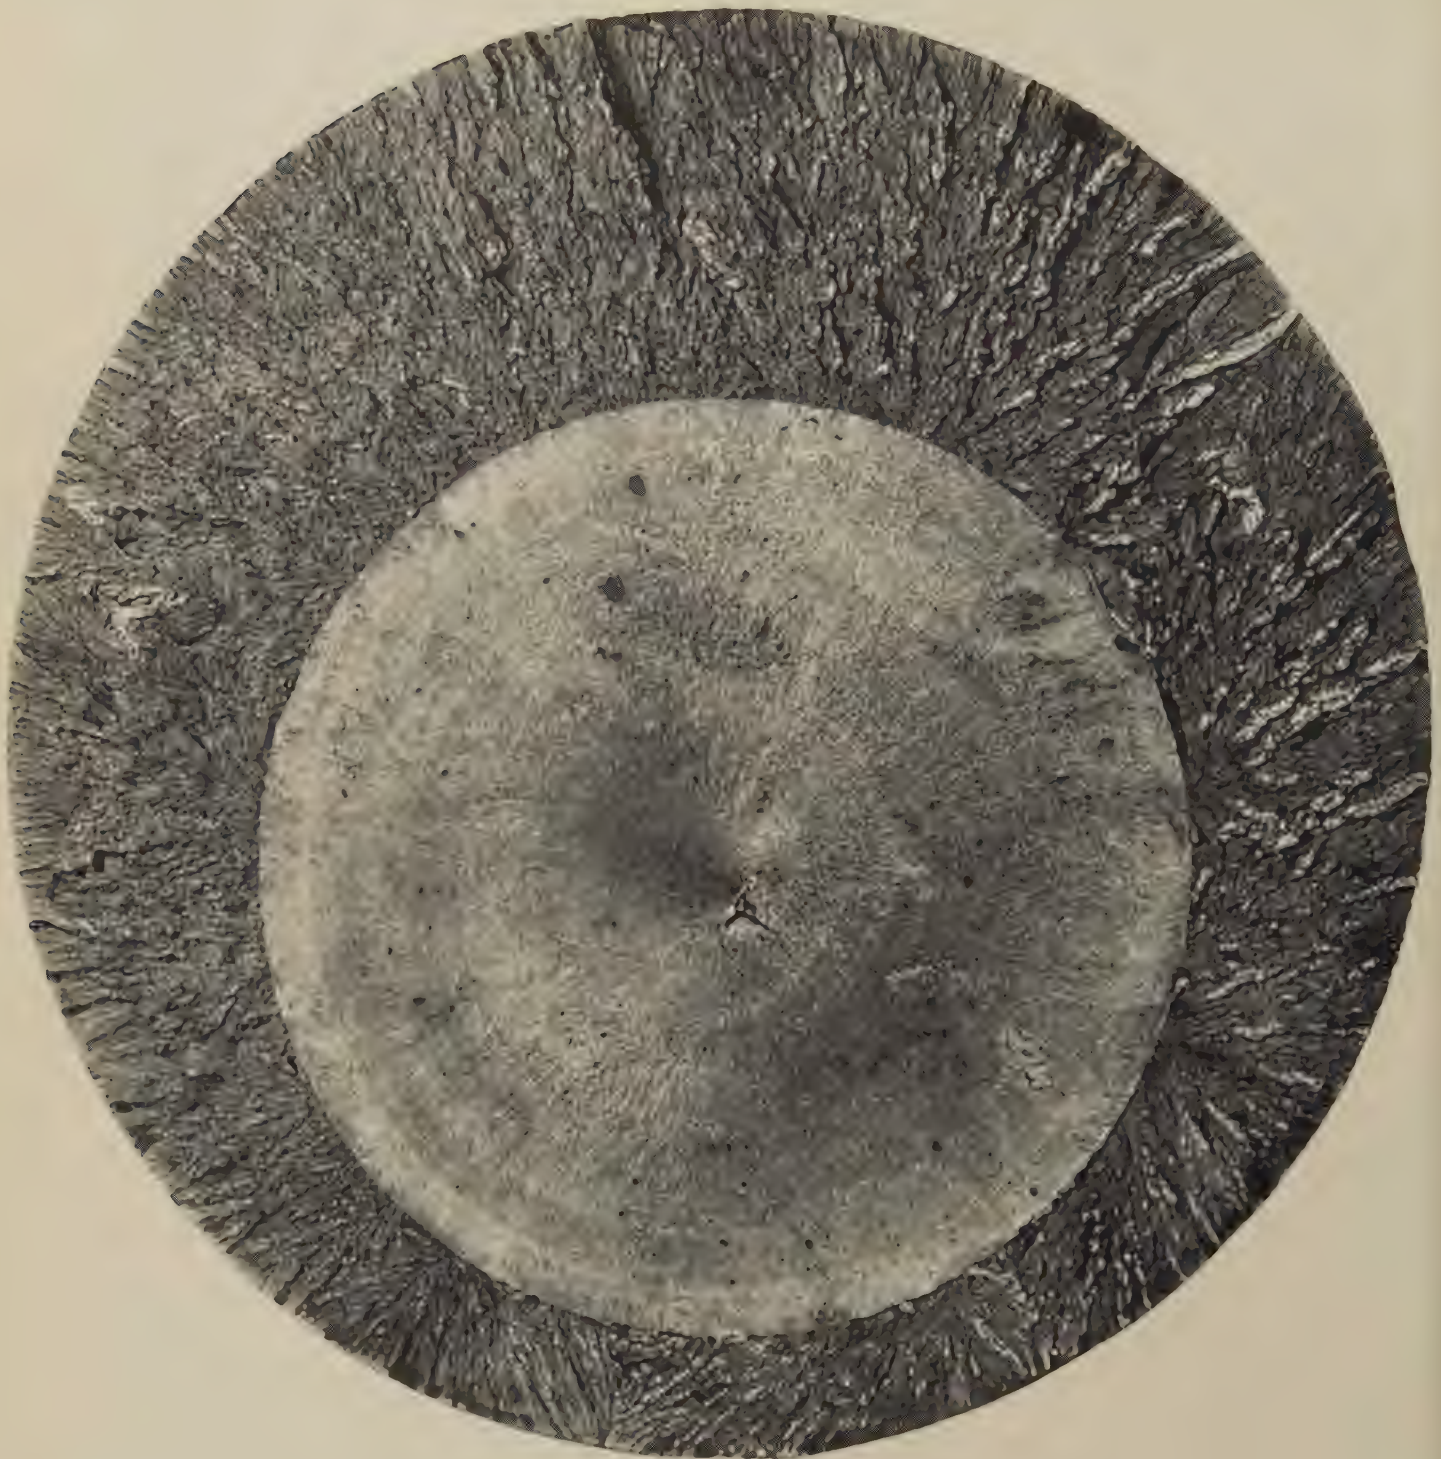
4954 Surface of a fatigue fracture in an 8-in.-diam piston rod of a steam hammer for forging. The rod was fabricated from 0.26% C, 0.70% Mn, 0.87% Ni, 1.00% Cr steel and heat treated to a hardness of Rockwell C 24 at the surface and Rockwell C 17 at the center of the section. This is an example of fracture caused by pure tensile fatigue, in which surface stress concentrations are absent and a crack may start anywhere in the cross section. In this instance, the initial crack formed at a forging flake slightly below center, grew outward symmetrically, and ultimately produced a brittle fracture without warning.

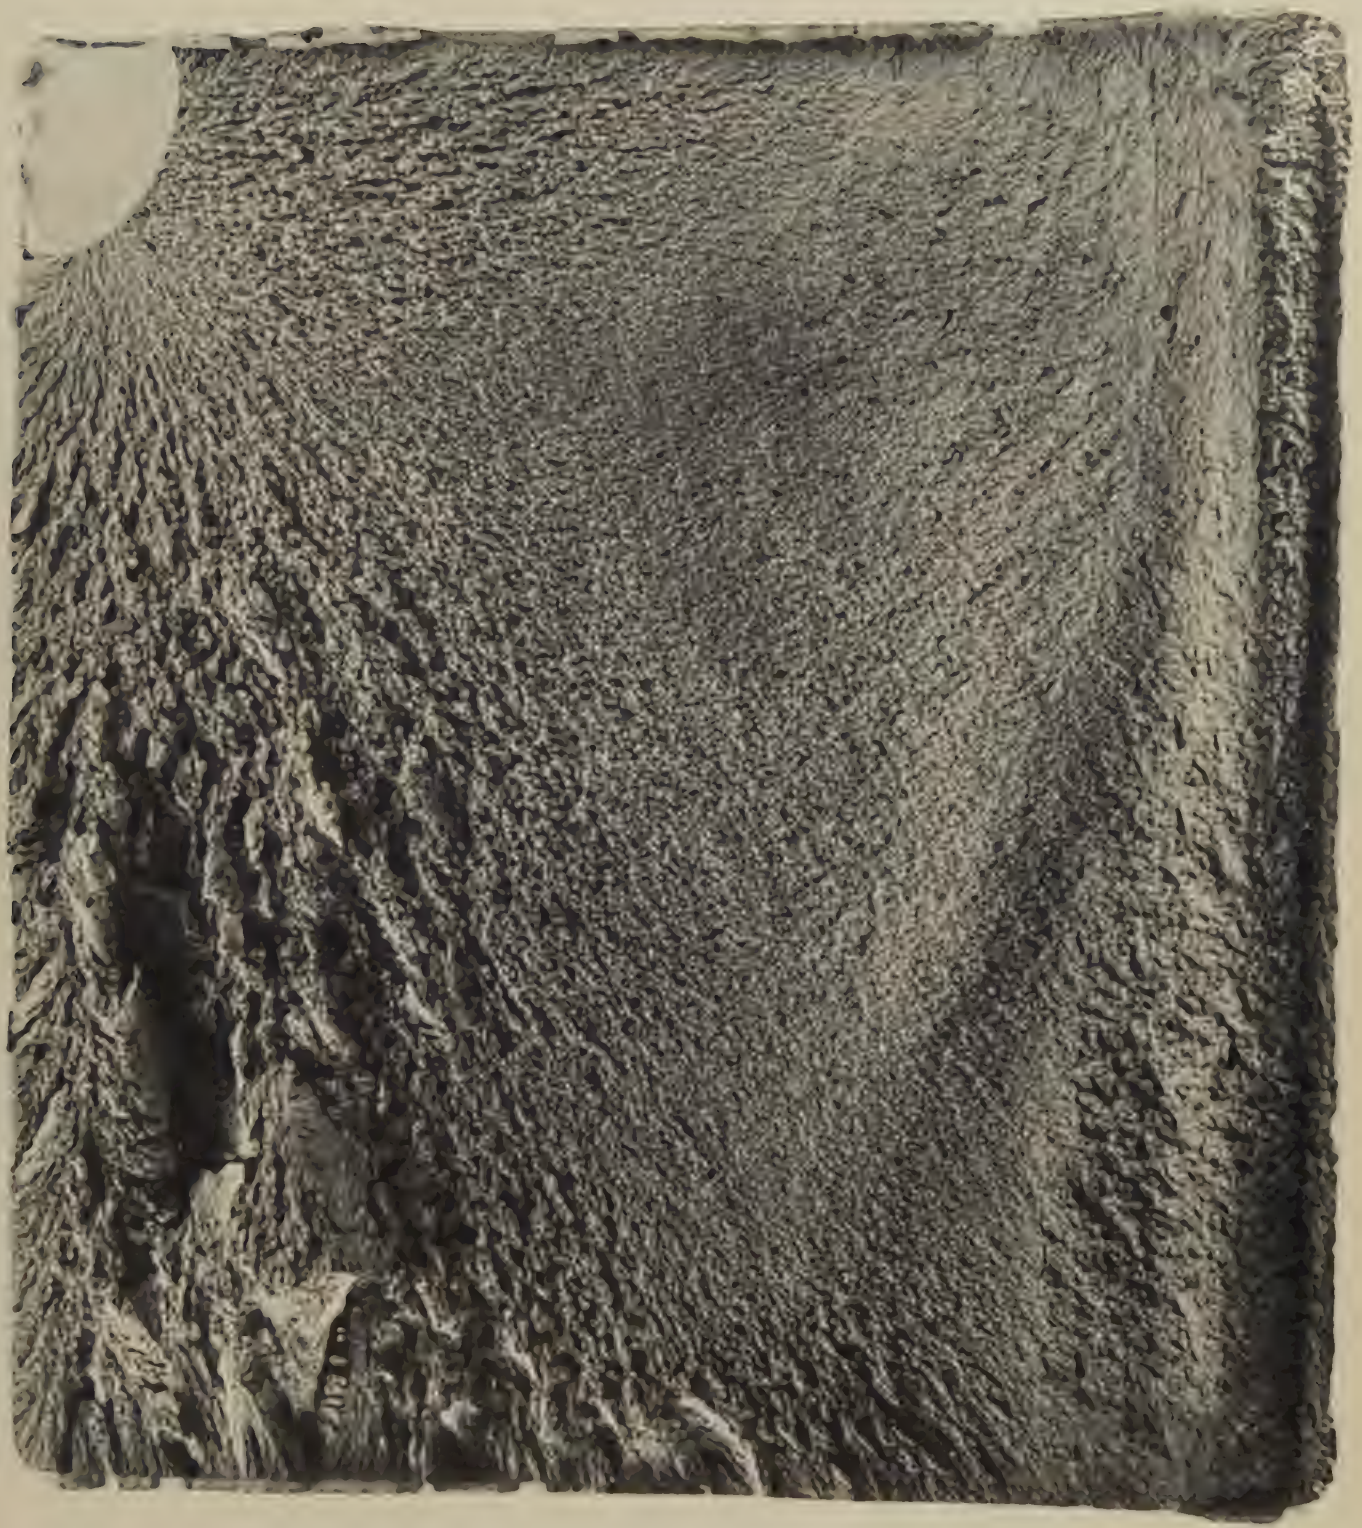
4955 Surface of a fracture in an equalizer bar, which supports the front end of a tractor, fabricated from D6B steel and heat treated to a hardness of Rockwell C 45 to 47. The bar was put into service for 200 hr and then returned to the laboratory, where it was flexed in fatigue to fracture at 60,000 cycles. Note the very fine texture of the fatigue-crack zone at the upper left corner. It is concluded that because there are no beach marks beyond that small corner zone, the remainder of the fracture occurred in a catastrophic manner. Shear lips are evident along the top and right edges, and may also be present around the lower left corner. (D6B steel contains 0.45% C, 0.80% Mn, 1.00% Cr, 0.50% Ni, 1.00% Mo, 0.10% V.)

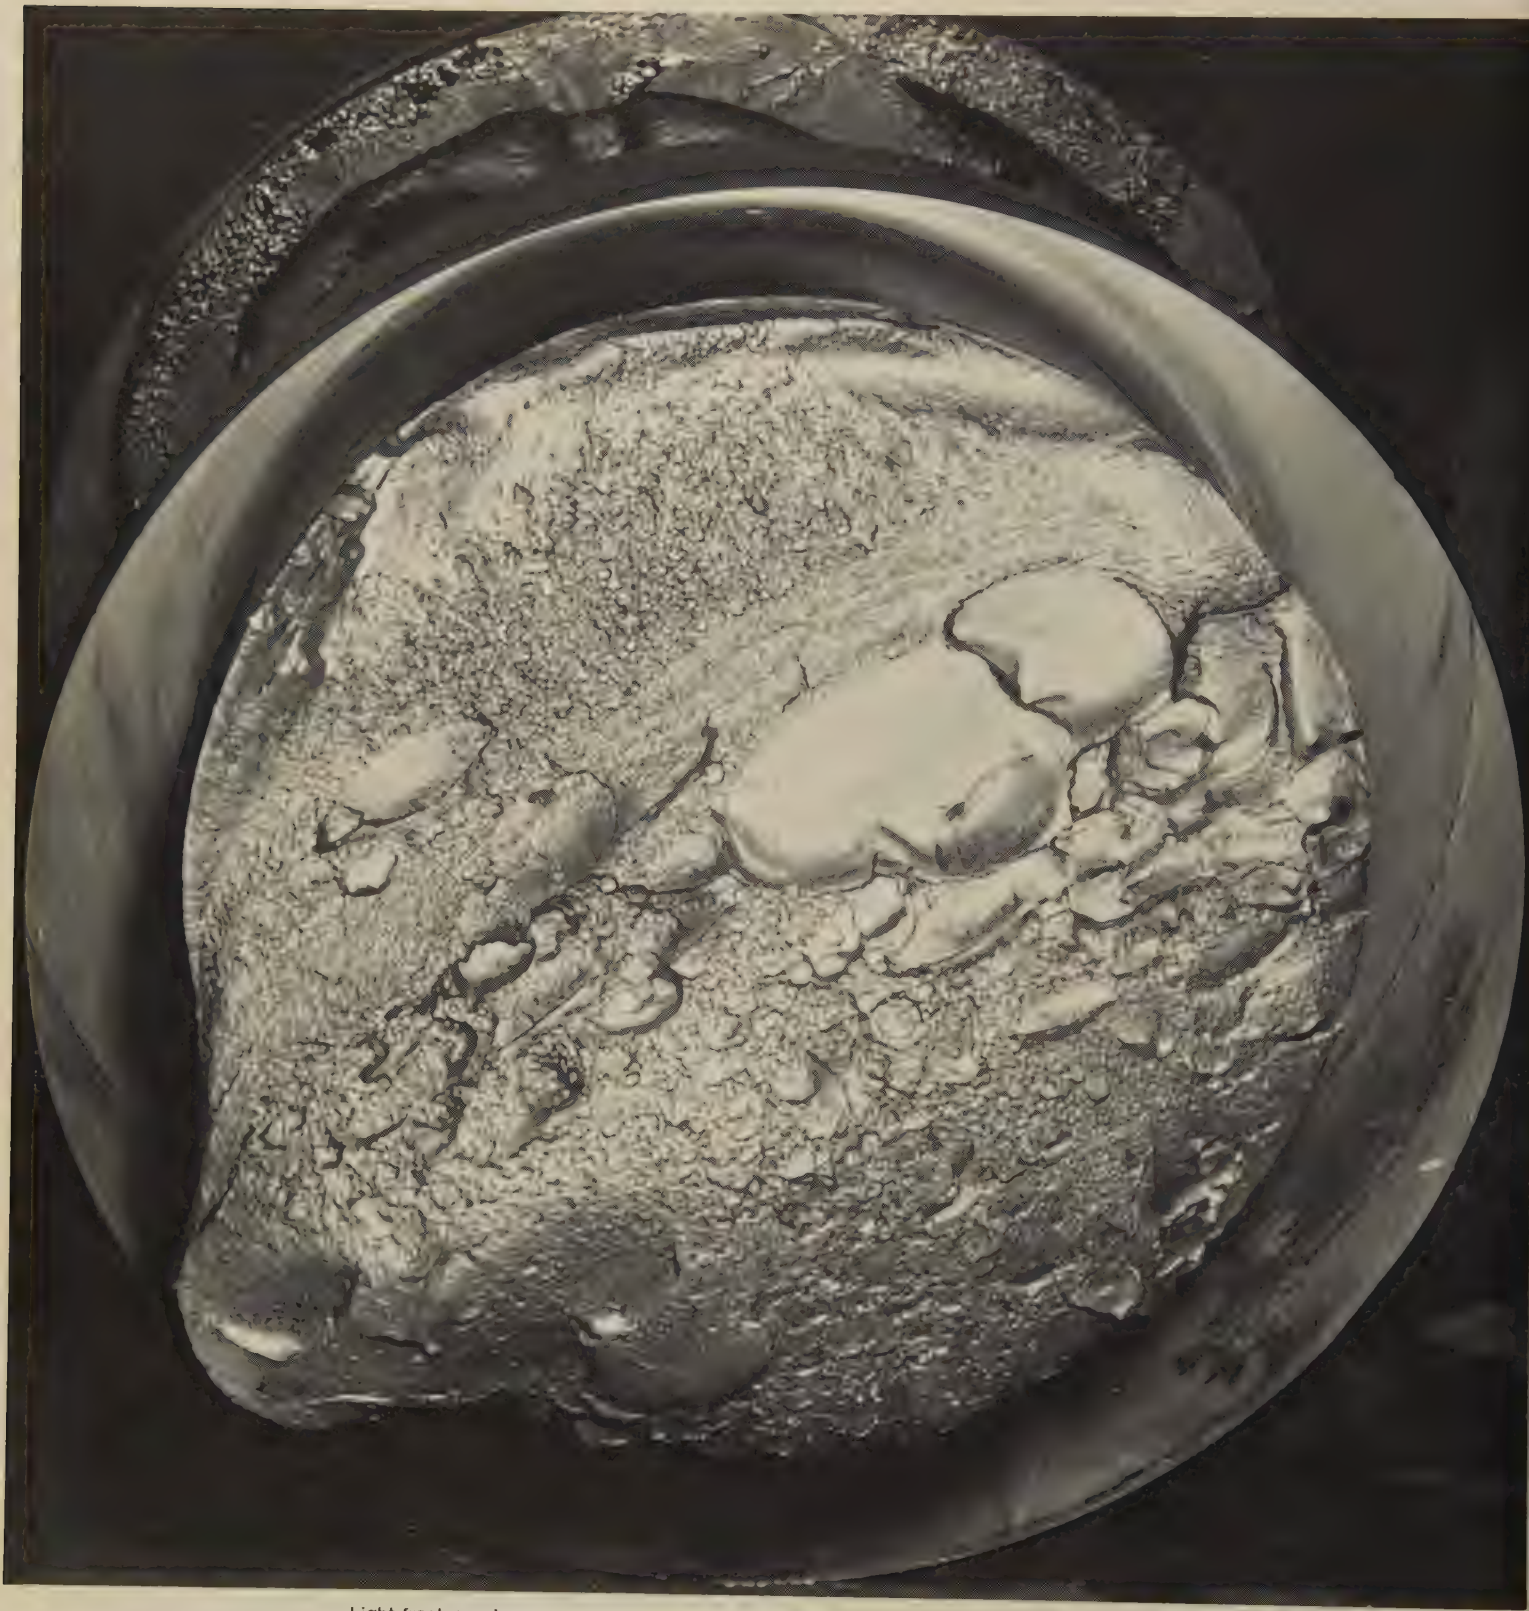
4956 Surface of a fatigue fracture through a journal of a crankshaft for a 6-in. upsetting machine. The crankshaft was forged of 4340 steel and was normalized to a yield strength of 593 MPa (86 ksi), a tensile strength of 807 MPa (117 ksi), 20.5% elongation and a hardness of 232 Bhn. Specimens cut from the crankshaft and reheat treated in exact accordance with prescribed practice had tensile strength of 945 MPa (137 ksi), 18% elongation and a hardness of 277 Bhn. The increased tensile strength and hardness indicate that the original heat treatment of the crankshaft was improper and led to a short fatigue life. See 4957 (facing page) for a view of the mating fracture surface.

4957 A view of the mating fracture surface to that shown in 4956 (facing page). The illumination here is at a different angle from that in 4956, with the result that in some locations it is difficult to determine which of the features are projections and which are depressions. It appears likely that there were several fatigue-crack nuclei around the journal perimeter; the principal nucleus probably was in the rubbed area at upper right here (upper left in 4956). There is a possibility that the crankshaft contained forging flakes and that some of these flakes were exposed during machining of the journal and initiated the fatigue cracks.

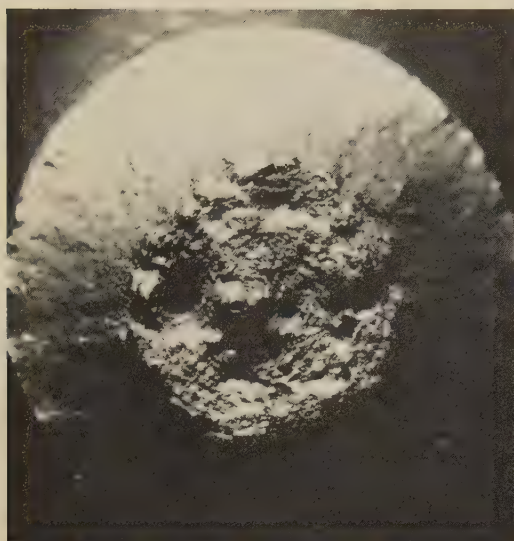
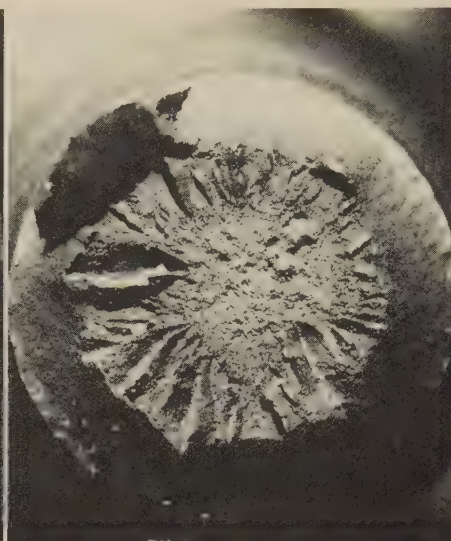
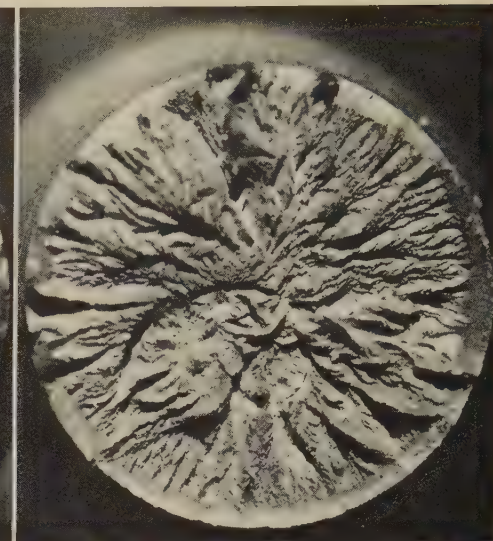
4958, 4959, 4960

Surfaces of tension-overload fractures produced at different temperatures in three unnotched specimens of 4340 steel, heat treated to a hardness of Rockwell C 35. The specimen in 4958 (left) was tested at 160 C (320 F). A shear lip is visible, surrounding a fibrous region. The specimen in 4959 (center) was tested at 90 C (194 F). At this lower test temperature, a radial fracture zone formed around the fibrous region, which formed first; also, the shear lip here is smaller than that in 4958. The specimen in 4960 (right) was tested at -80 C (-112 F). At this still lower test temperature, no fibrous region formed. Instead, fracture formed a radial zone that extends nearly to the specimen surface and terminates in a narrow shear lip.

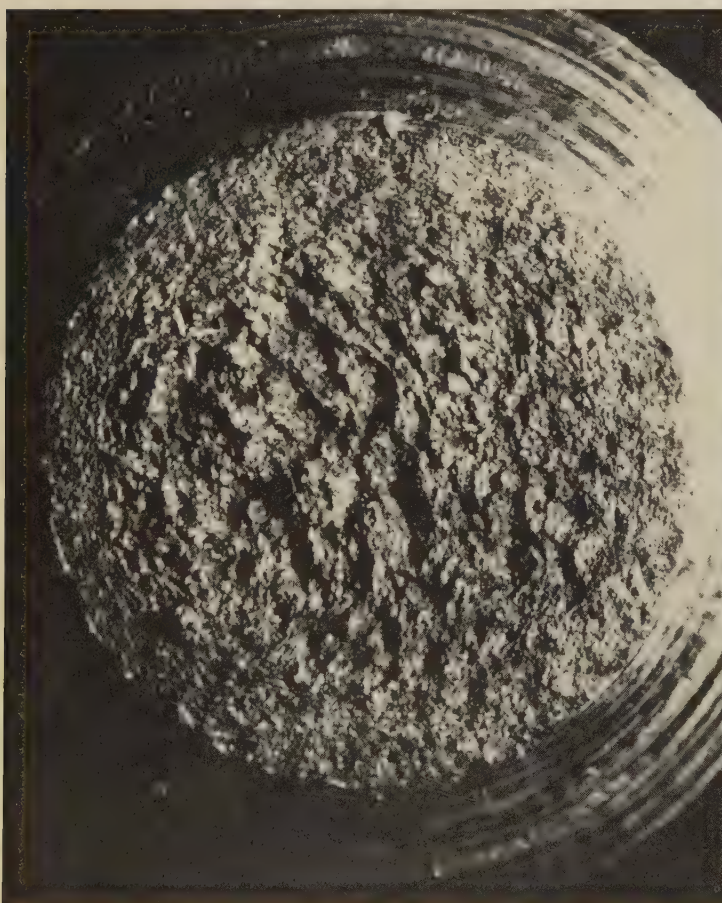
4961 A tension-overload fracture in a notched specimen of 4340 steel, heat treated to a hardness of Rockwell C 27 and tested at -40 C (-40 F), showing a completely fibrous surface. See 4962 and 4963 (right, and on facing page) for fractures in similar specimens tested at different temperatures.

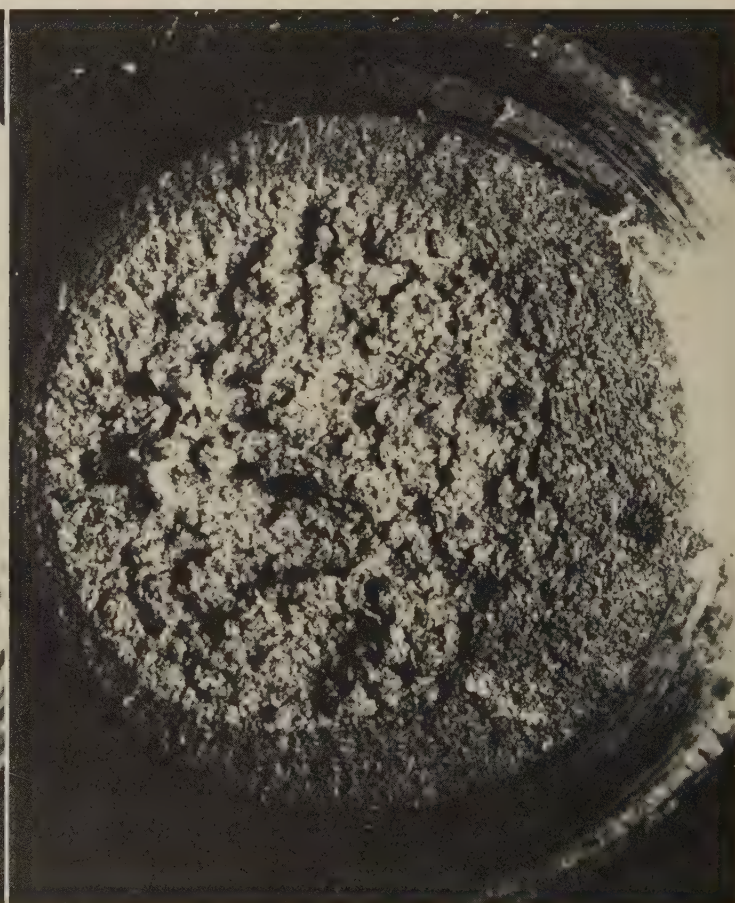
4962 Surface of a tension-overload fracture in another notched specimen of 4340 steel, the same as in 4961 but tested at -120 C (-184 F). Two distinctly different fracture-surface zones are visible; a fibrous zone, which originated at the notch, surrounds a radial region of final, fast fracture.

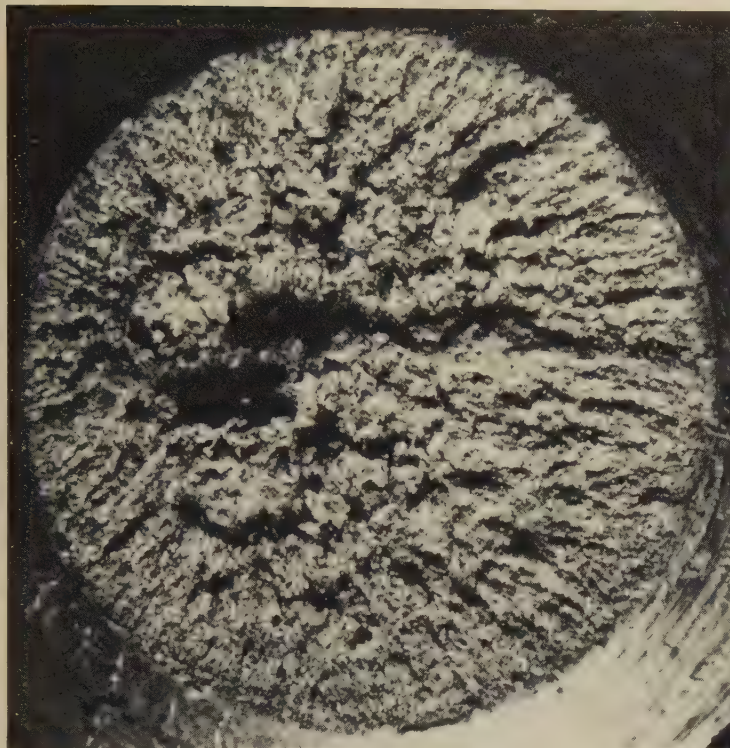
4963 Surface of a tension-overload fracture in a third notched specimen of 4340 steel, the same as those in 4961 and 4962 but tested at -155°C (-247°F). At this low test temperature, a completely radial fracture was produced. The surface shows no fibrous zone, only radial marks.

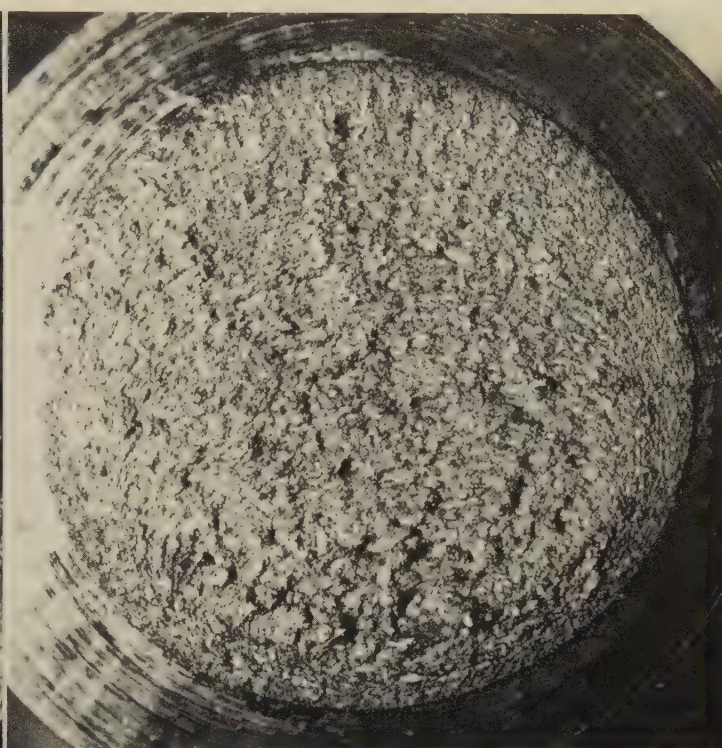
4964 A tension-overload fracture in a notched specimen of 4340 steel similar to those in 4961 to 4963 but heat treated to a hardness of Rockwell C 35. Tested at -40°C (-40°F). The surface shows only fibrous marks. See 4965 and 4966, below, for surfaces of fractures in similar specimens at different test temperatures.

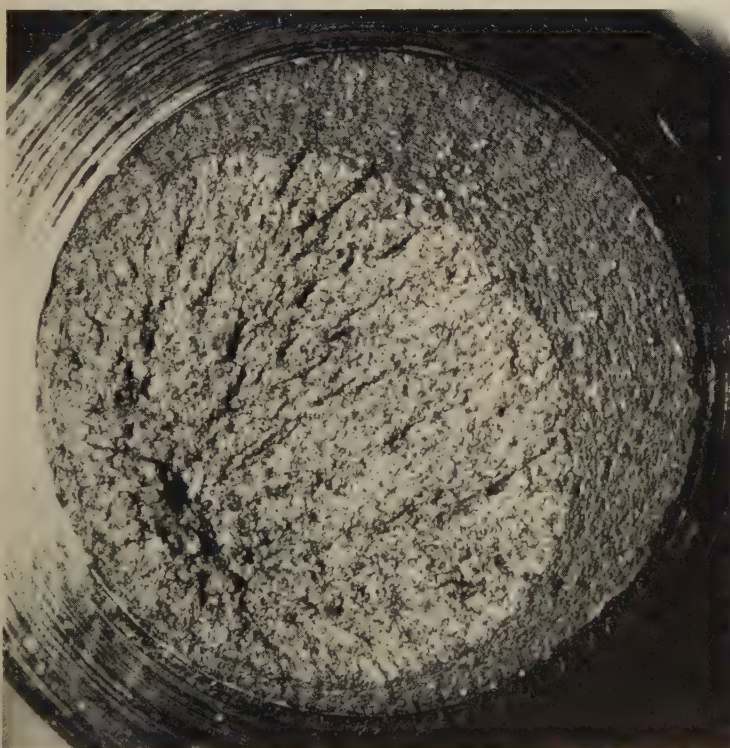
4965 Surface of a tension-overload fracture in a notched specimen of 4340 steel the same as the specimen shown in fractograph 4964, but tested at -80°C (-112°F). A fibrous zone, which originated at the notch, surrounds a radial zone, which is off-center because of nonsymmetrical crack propagation.

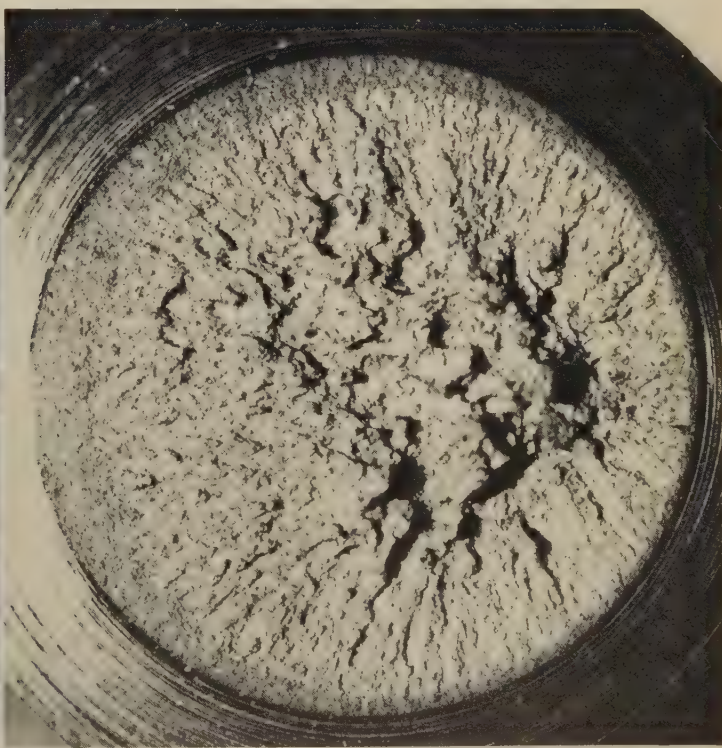
4966 Tension-overload fracture in a notched 4340 steel specimen same as in 4964 and 4965, but tested at -155°C (-247°F). Even at this very low temperature, a small annular zone of fibrous fracture was formed next to the notch. Final, fast fracture produced the radial marks in the central region.

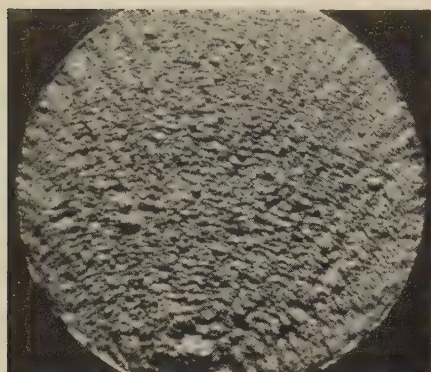
4967 180 C (356 F) 8×

Shown above are fracture surfaces of three notched tensile-test specimens prepared from 4340 steel that had been austenitized, quenched, and tempered at 315 C (600 F) to provide the following room-temperature properties: yield strength of 1558 MPa (226 ksi), unnotched tensile strength of 1758 MPa (255 ksi), and notched tensile strength of 1765 MPa (256 ksi). The specimens were broken by tension overload at the temperatures indicated beneath the fractographs. The fracture surface shown in 4967 is completely fibrous. Lowering the test temperature from 180 C (356 F) to 90 C (194 F) resulted in the formation of a very narrow, obscure fibrous rim enclosing a zone of radial marks (see 4968). Lowering the test temperature further, to 26 C (79 F), produced a fracture made up entirely of radial features (see 4969).

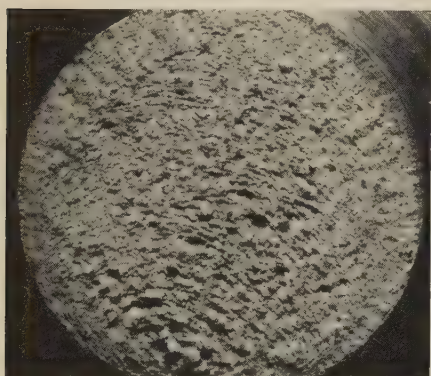
4970 0 C (32 F) 8×

Shown above are fracture surfaces of three notched tensile-test specimens prepared from 4340 steel that had been austenitized, quenched, and tempered at 480 C (896 F) to provide the following room-temperature properties: yield strength of 1234 MPa (179 ksi), unnotched tensile strength of 1310 MPa (190 ksi), and notched tensile strength of 1903 MPa (276 ksi). The specimens were broken by tension overload at the temperatures indicated beneath the fractographs. The specimen shown in 4970 was broken at 0 C (32 F) but, in contrast to the specimen in 4969, which was tempered at 315 C (600 F), yielded a completely fibrous fracture. The fracture shown in 4971, which was produced at -80 C (-112 F), shows a fibrous rim surrounding a zone of radial marks. The fracture shown in 4972, which was produced at -196 C (-321 F), shows only radial marks.

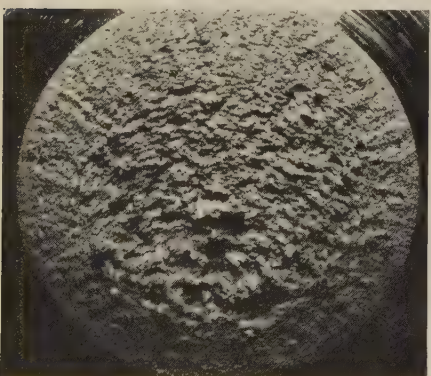
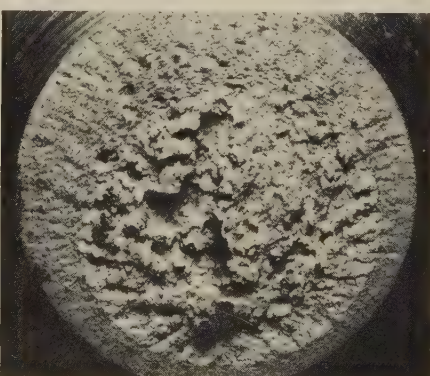
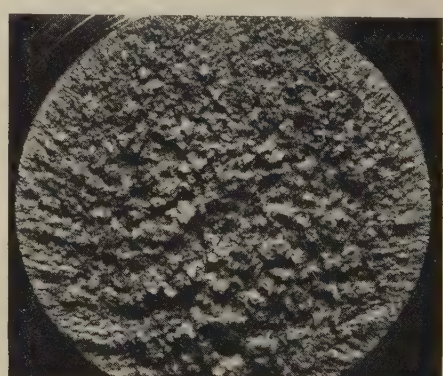
4973 -60 C (-76 F) 8×

4974 -130 C (-202 F) 8×

4975 -196 C (-321 F) 8×

Fracture surfaces of three notched tensile-test specimens prepared from 4340 steel that had been austenitized, quenched, and tempered at 650 C (1202 F) to provide the following room-temperature properties: yield strength, 917 MPa (133 ksi); unnotched tensile strength, 1014 MPa (147 ksi); notched tensile strength, 1489 MPa (216 ksi). The specimens were broken by tension overload at the temperatures indicated beneath the fractographs. The specimen in 4973 was broken at -60 C (-76 F) but displays a completely fibrous surface. The fracture in 4974 was produced at -130 C (-202 F); note the appreciable increase in the size of the fibrous zone, compared with that in 4971, caused by the lower strength that resulted from tempering at 650 C (1202 F). The specimen in 4975, which was broken at -196 C (-321 F), exhibits a fracture surface containing only radial marks.

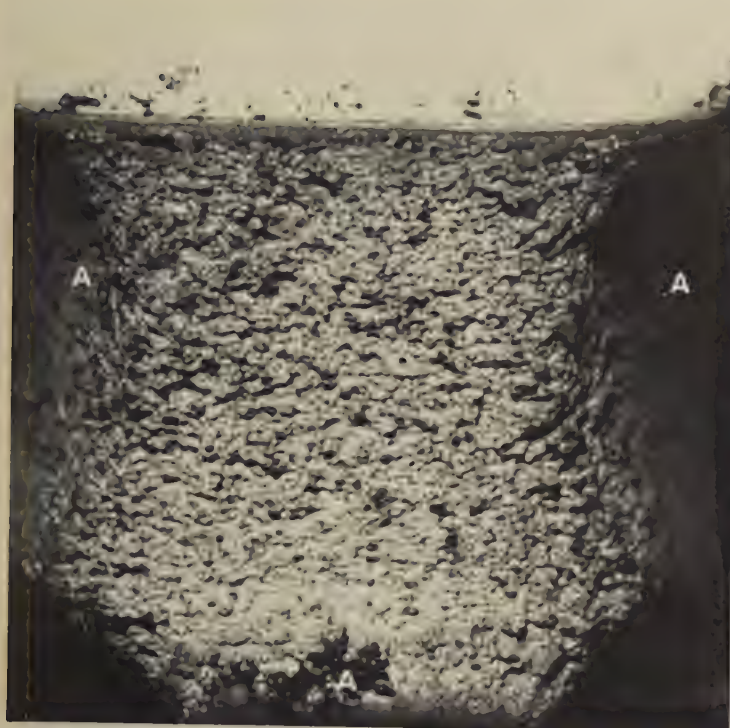
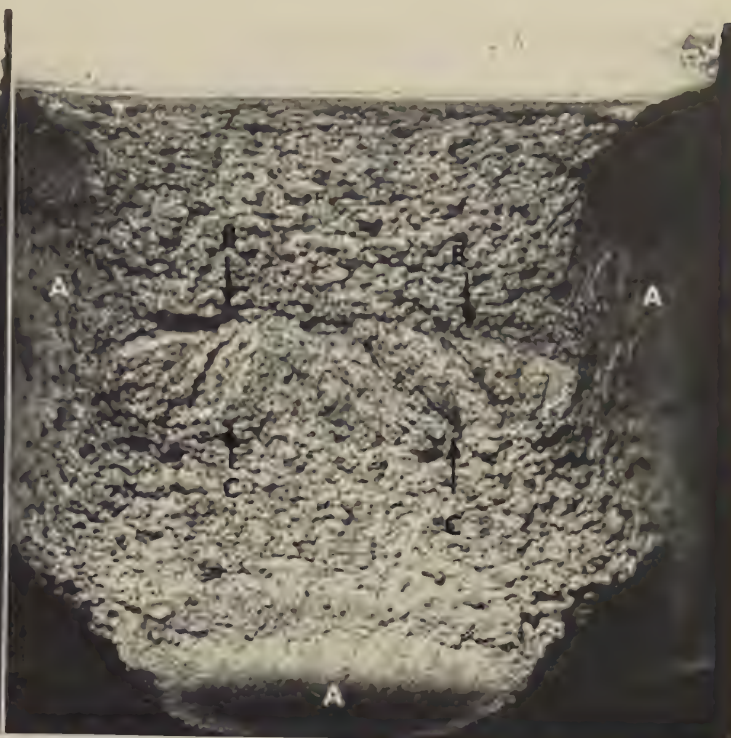
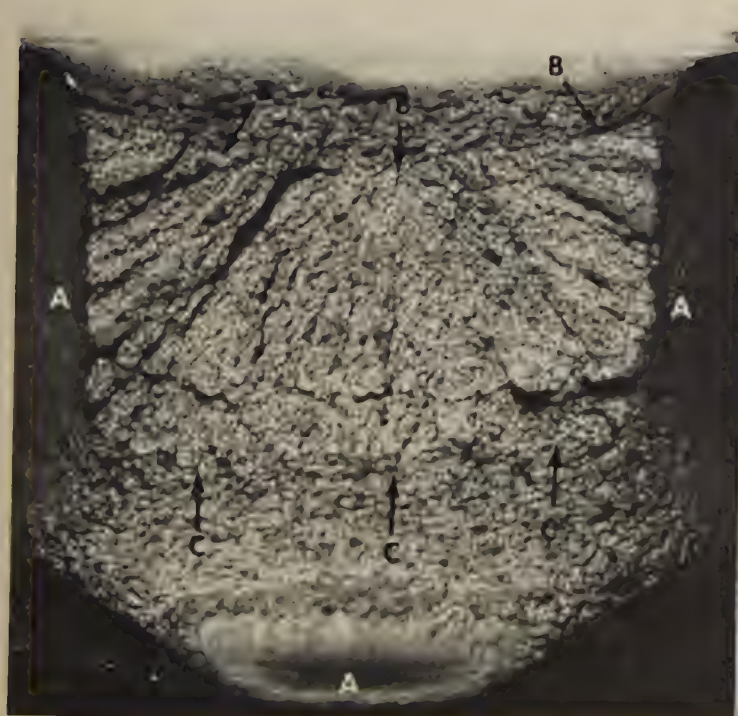
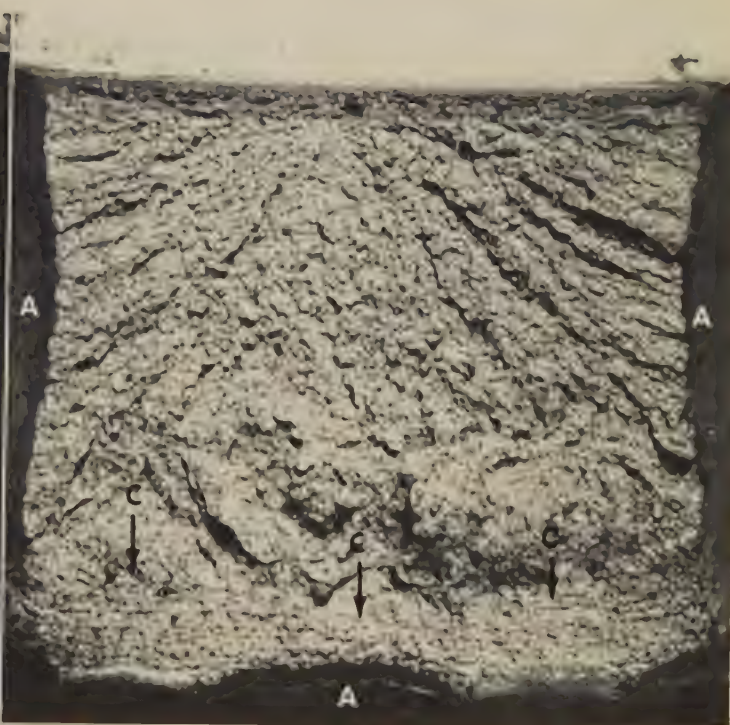
4976

4977

4978

4979

The four light fractographs on this page show the surfaces of impact fractures in Charpy specimens of 4340 steel heat treated to a hardness of Rockwell C 27, and depict the changes in surface characteristics as test temperature was decreased. The specimen in fractograph 4976, which was broken at -80 C (-112 F), shows a fibrous fracture surface containing shear lips (at A's). The specimen in fractograph 4977 was broken at -90 C (-130 F). This temperature is close to the ductile-brittle transition temperature, as indicated by the presence of a small area of radial marks (between arrows B and arrows C) in the center of the otherwise fibrous fracture sur-

face. Shear lips are present here also (at A's). The specimen in fractograph 4978 was broken at -100 C (-148 F) and shows an area of radial marks (between arrows B and arrows C) much larger than that in 4977 while retaining fibrous regions above arrows B (near the notch) and below arrows C. The shear lips here (at A's) are comparable to those in 4976 and 4977. The specimen in 4979 was broken at -120 C (-184 F); its fracture surface contains a radial zone larger than that in 4978 but still shows a small area of fibrous fracture below arrows C (opposite the notch). Also, the shear lips here (at A's) are appreciably smaller than those in 4978.

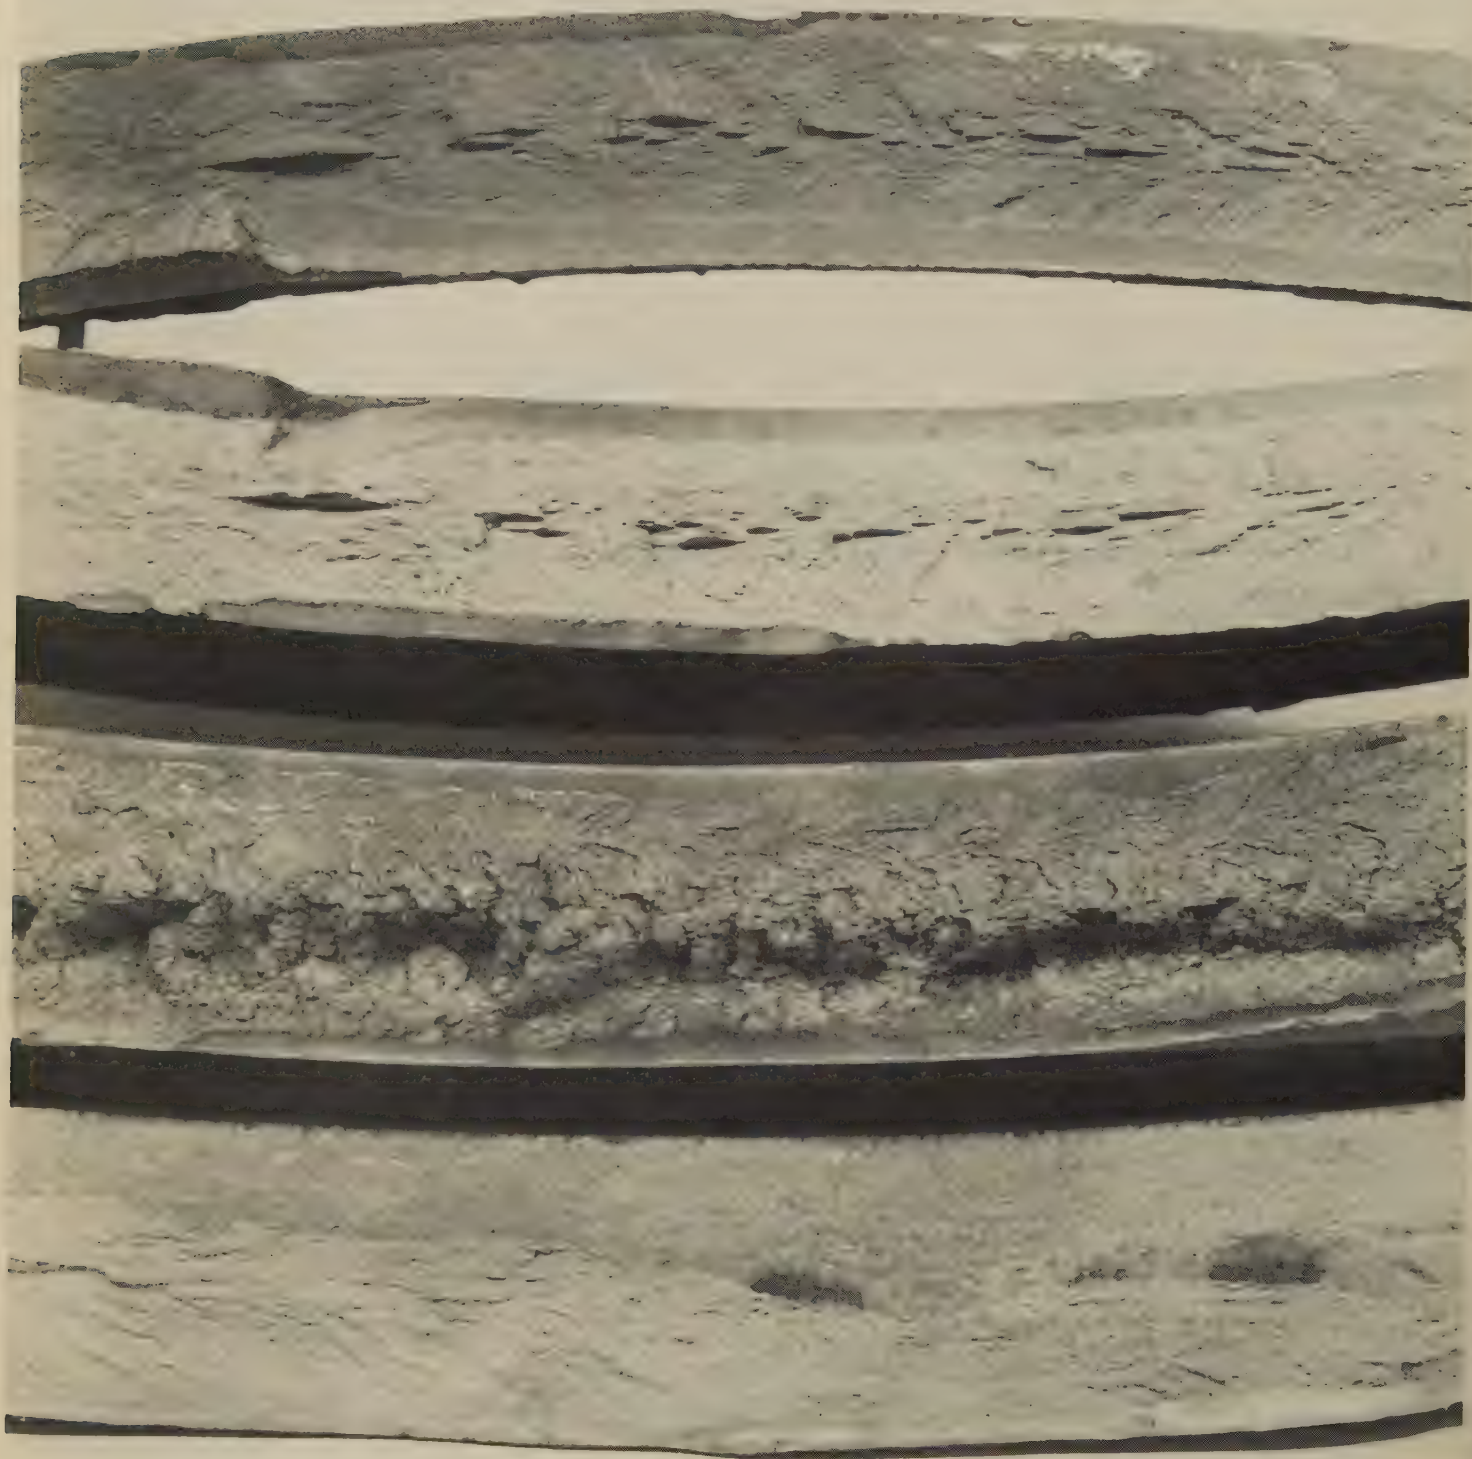
Light fractograph (four surfaces)

4980 Four fracture surfaces of a hemispherical accumulator head of high-strength low-alloy steel (0.15% C, 0.8% Mn, 0.6% Cr, 0.85% Ni) that broke into several pieces during pressure testing at room temperature. Hardness ranged from Rockwell C 28 to Rockwell C 39. Fracture originated at a thin spot in the wall, where banding was present also. At top are mating surfaces of a fracture near the room-temperature cleavage. The fracture surface third from the top is very coarse-grained, whereas the surface at bottom is fine-grained and silky; the difference in appearance between these two surfaces may have resulted from a difference in rate of crack propagation.

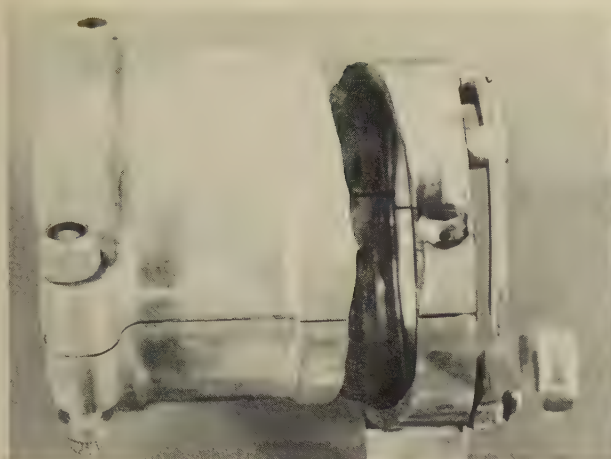
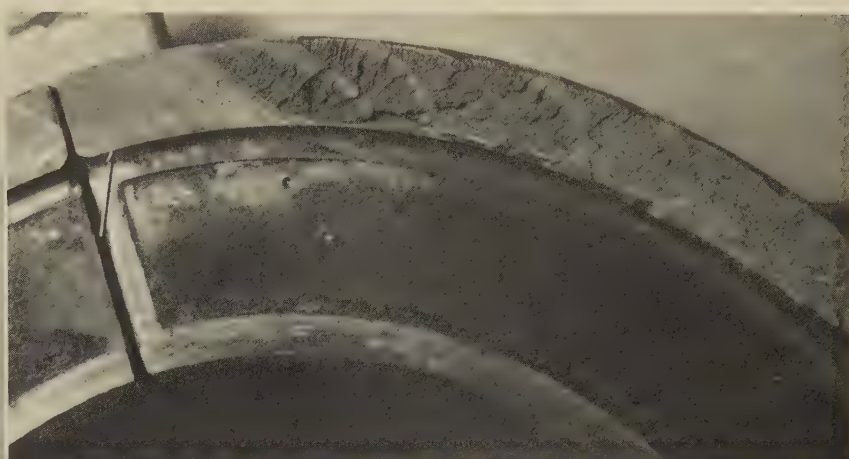
4981 A view of a broken aircraft-propeller hub clamp of 4340 steel heat treated to a hardness of Rockwell C 40, showing a circumferential fatigue fracture. Fracture began at two origins in a fillet of an inner sidewall. See also 4982 to 4986.

4982 A portion of the fracture surface of the broken clamp in 4981. One fatigue-crack origin is marked by an arrow; the other is just to the left of the clamp parting line. The crack that began at the origin at the arrow propagated to the right by continuous fatigue cracking for about $\frac{3}{8}$ in. and then continued alternately by rapid tearing and slow fatigue cracking.

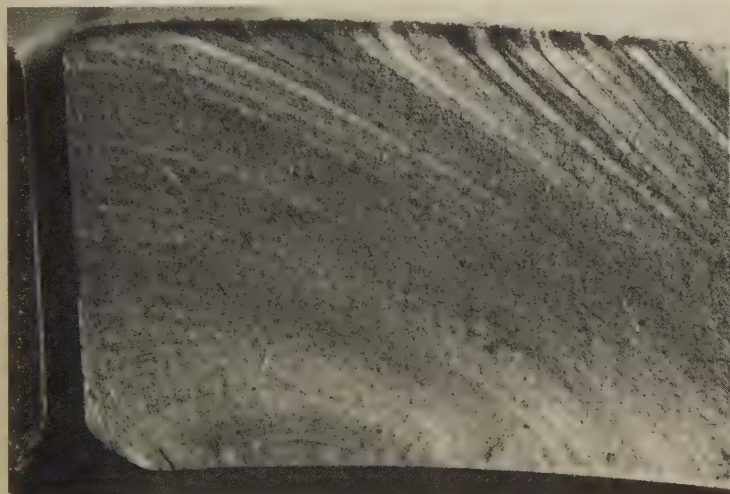
4983 Higher-magnification view of the fatigue-crack origin at arrow in 4982. In the fillet beneath the lower edge of the fracture, several corrosion pits are faintly visible in an area where cadmium plating was required but was found to be missing.

4984 Area just to the right of the zone of continuous fatigue cracking in 4982, showing intermittent zones of rapid tearing and slow fatigue cracking. Sharply defined beach marks are visible in the fatigue zones.

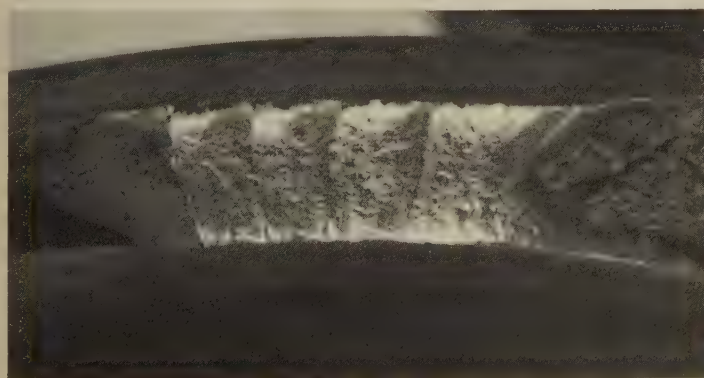
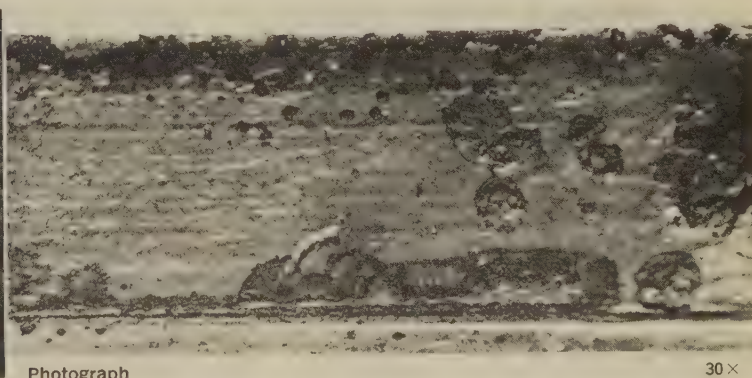
4985 A view of the fracture in 4981, showing an area near the onset of final, fast fracture. About 45% of the fracture surface shown here is composed of fatigue patches interspersed among regions of rapid tearing, which suggests that the hub clamp underwent periodic changes in load amplitude.

4986 A view of the inside surface of the broken clamp in 4981, clearly displaying the corrosion pits that are dimly visible in 4983 in the fillet below the edge of the fracture, near the fatigue-crack origin. The many small pits along the edge of the fracture surface (shown in profile at top) are believed to have been mainly responsible for the initiation of the fatigue cracks.

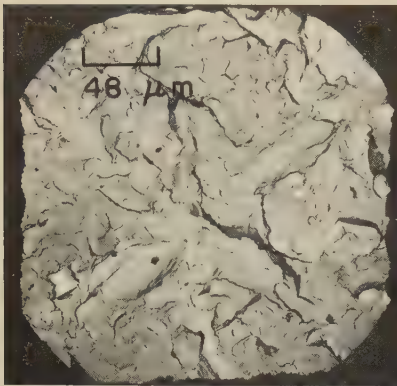
TEM fractograph (p-c replica) 210×

4987 Impact fracture in a specimen of AMS 6434 (4335 mod) steel quenched and then tempered at 204 C (400 F) to a yield strength of about 1550 MPa (225 ksi) and broken at -196 C (-321 F), showing a woody type of cleavage-fracture surface.

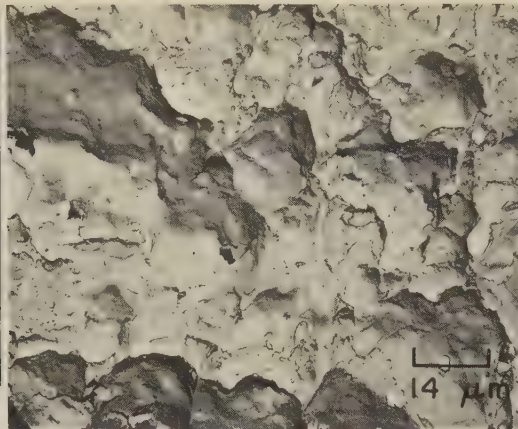
TEM fractograph (p-c replica) 700×

4988 Impact fracture in a specimen of AMS 6434 (4335 mod) steel (same properties as 4987) broken at room temperature, showing fairly large equiaxed dimples, which are characteristic of tension-overload fractures.

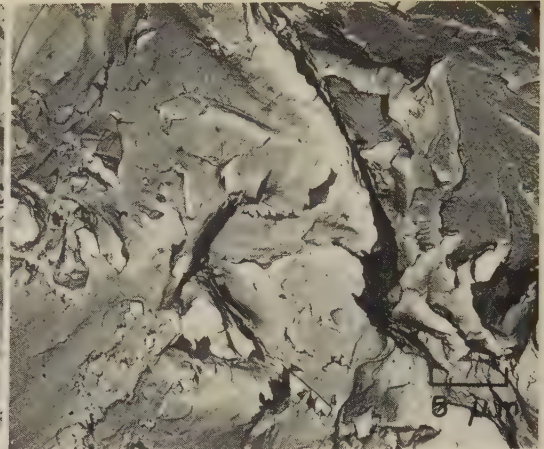
TEM fractograph (p-c replica) 2000×

4989 Fracture surface of an air flask of AMS 6434 (4335 mod) steel that was broken in service. This complicated surface contains several quasicleavage facets.

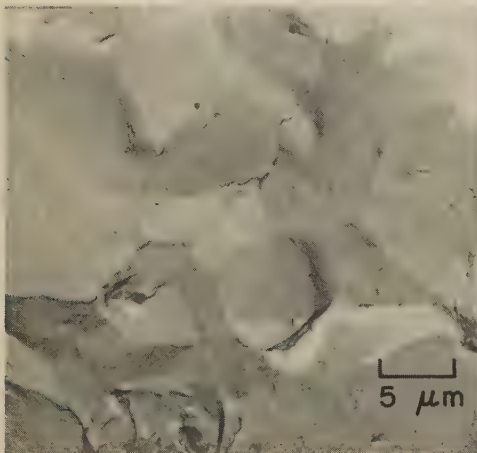
TEM fractograph (p-c replica) 2000×

4990 Stress-corrosion fracture surface of a specimen of 4340 steel that was stressed in distilled water, which resulted in clean intergranular facets plus a small number of fine tear ridges.

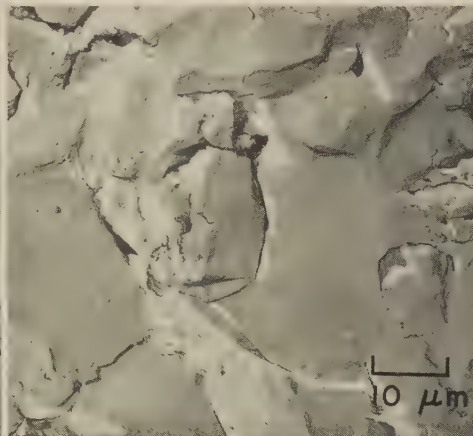
TEM fractograph (p-c replica) 1000×

4991 Surface of a stress-corrosion fracture in a specimen of 4340 steel that was hardened and tempered, then stressed in a 3½% NaCl solution. Intergranular facets, tear ridges and quasicleavage facets are evident. Compare with 4992.

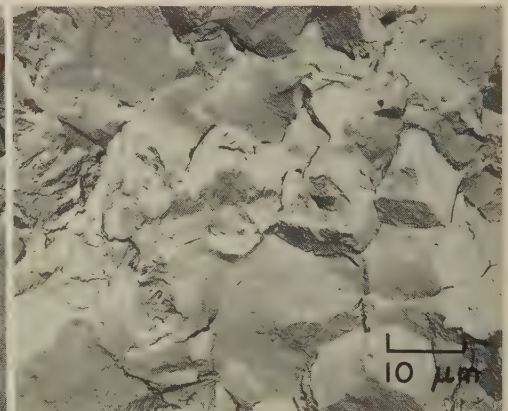
TEM fractograph (p-c replica) 1000×

4992 Impact-fracture surface of a specimen of hardened and tempered 4340 steel embrittled by charging with hydrogen. The crack mechanism here is hydrogen cracking, not stress-corrosion cracking, yet this fracture surface resembles that in 4991. (See also 4993 through 4998.)

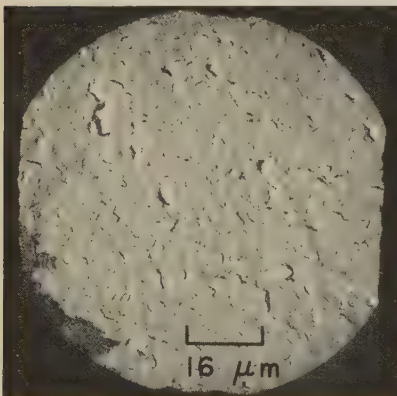
TEM fractograph (p-c replica) 630×

4993 Surface of a second impact fracture in hydrogen-embrittled 4340 steel; an excellent example of a surface composed of transgranular, cleavage facets.
